**RE:** *Building Safety Inspection Reports*  
**Subject:** *700 Pine Drive, Pompano Beach, FL 33060*  
**Folio:**

# STRUCTURAL SAFETY INSPECTION REPORT FORM

a. Name on Title: **Garden Point Condo**

b. Street Address: **700 Pine Drive, Pompano Beach, FL 33060**

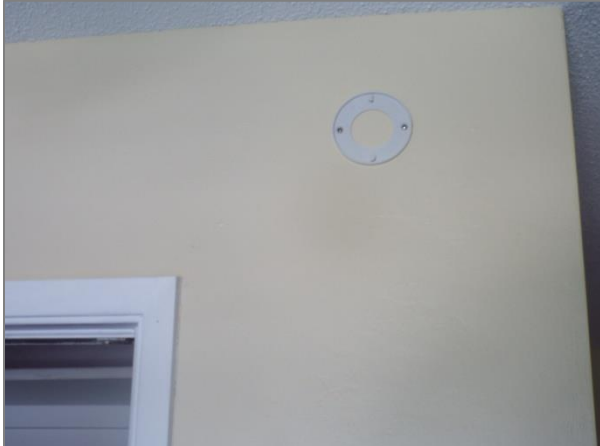
### Smoke Detectors

**Several Missing**

**Install Missing Smoke Detectors. Confirm Existing Smoke Detectors Are In Working Condition.**

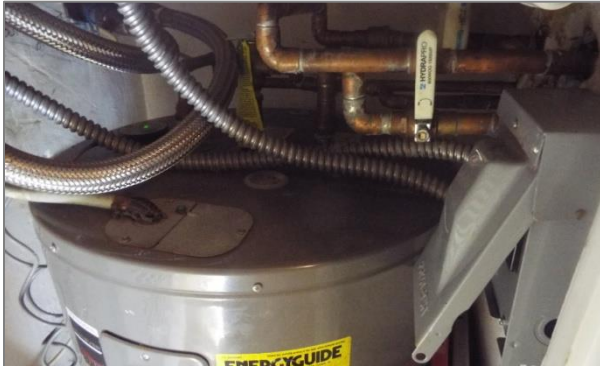
**Unit 101**

**No Access To Water Heater Disconnect.**

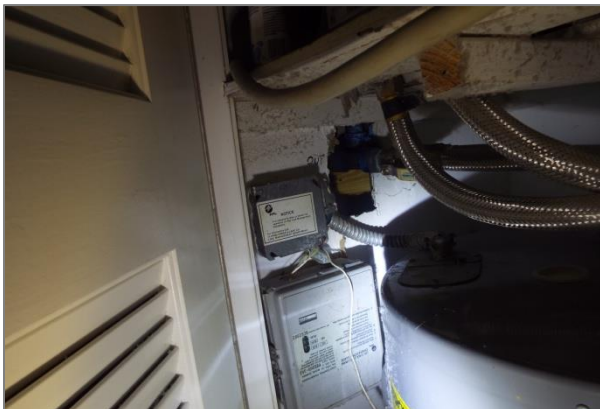
**Unit 103**

**Loose Cable/Exposed Wires At FPL Energy Management Box – Left Of Water Heater.**

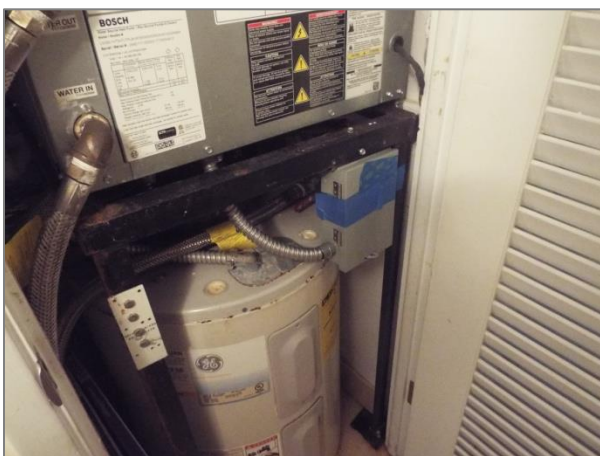
**Unit 110**

**Loose Cable/Exposed Wires Going Into Disconnect Right Of Water Heater.**

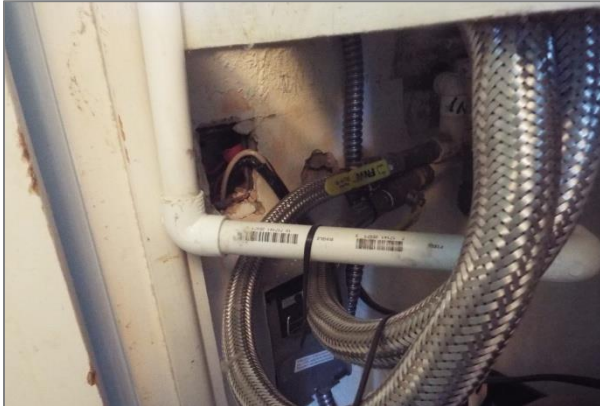
**Unit 201**

***Exposed Wires Under Air Handler.***

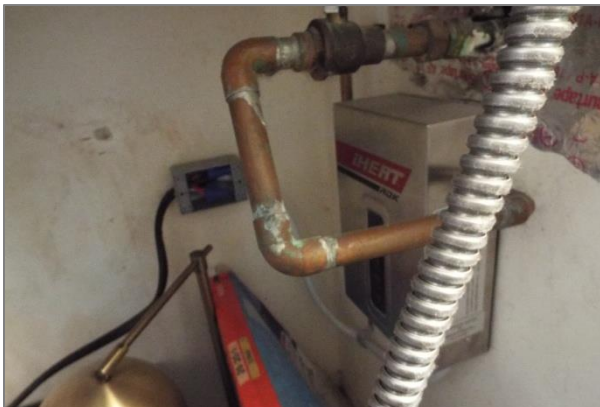
**Unit 201**

***Cover Plate Is Missing Left Of Tankless Water Heater.***

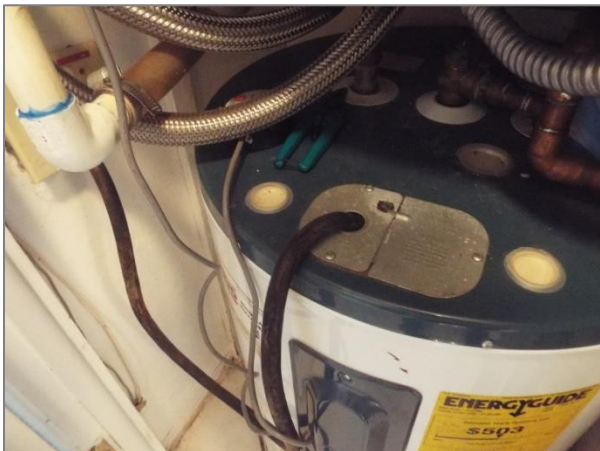
**Unit 204**

***Strain Relief Connector Is Missing On Wire Going Into Water Heater.***

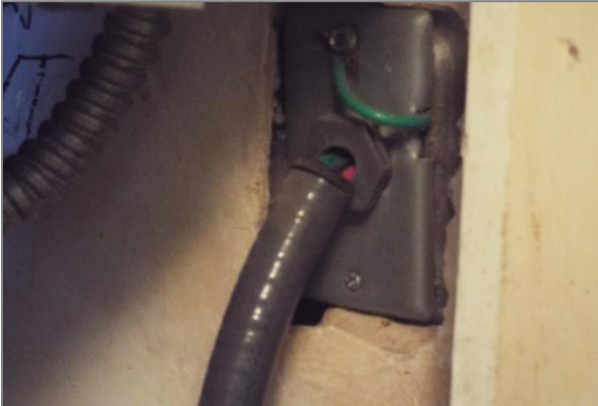
**Unit 210**

***Lose Cable/Exposed Wires At Electrical Box Under Air Handler.***

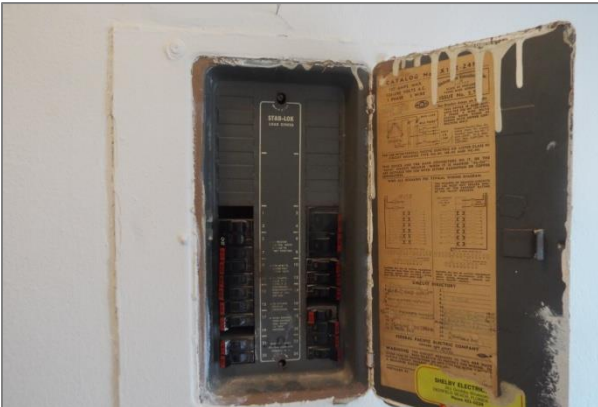
**Unit 301**

***Knock Outs Missing In Electrical Panel.***

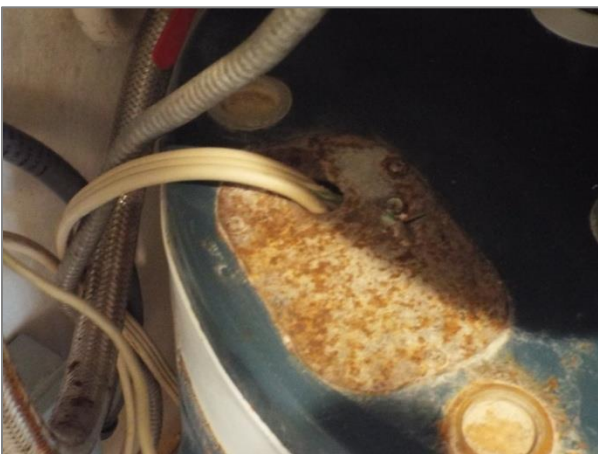
**Unit 301**

***Strain Relief Connector Is Missing On Wire Going Into Water Heater.***

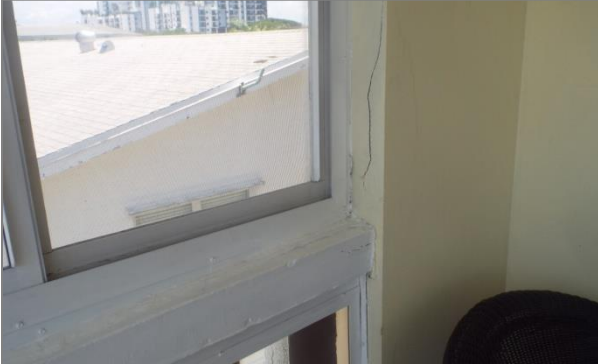
**Unit 301**

- **Spalling Observed On Unit 301 And 306 Balcony Columns**
- **See Attached Photos.**

***Spalled Concrete At NW Corner Of Balcony.***

**Spalling On Balcony Columns Of Units 301 And 306.**

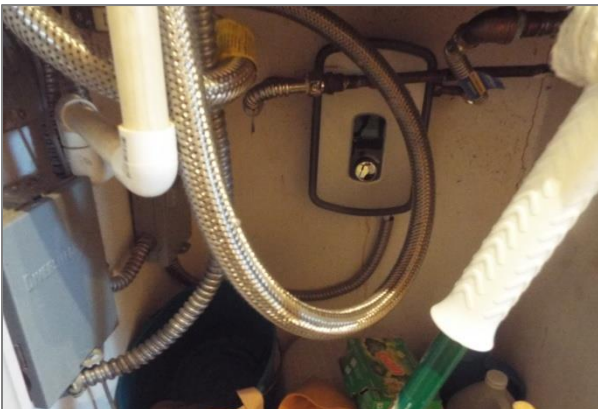
**Unit 303**

***Loose Wire Going Into Junction Box Under Air Handler.***

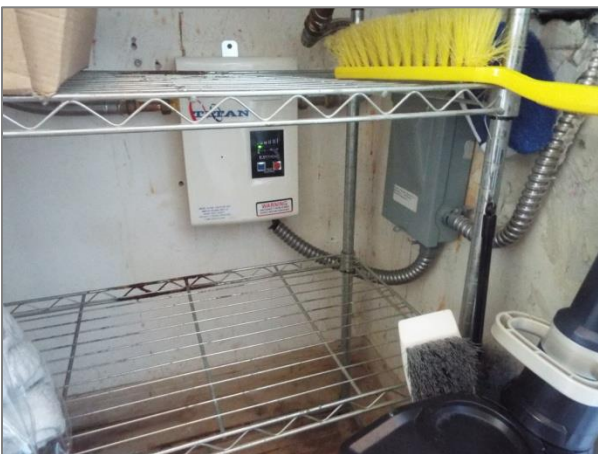
**Unit 305**

***Loose Cable/Exposed Wires Under Tankless Water Heater.***

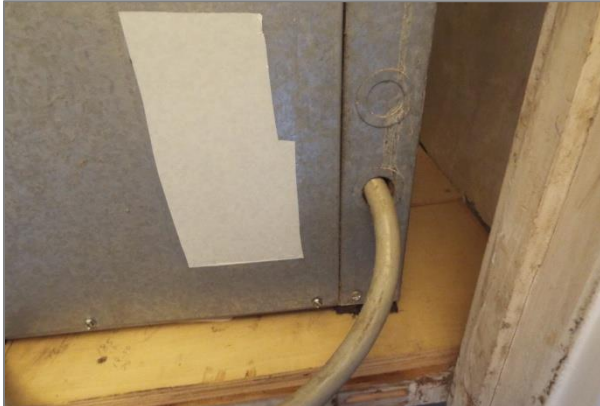
**Unit 306**

***Strain Relief Connector Is Missing On Wire Going Into The Air Handler.***

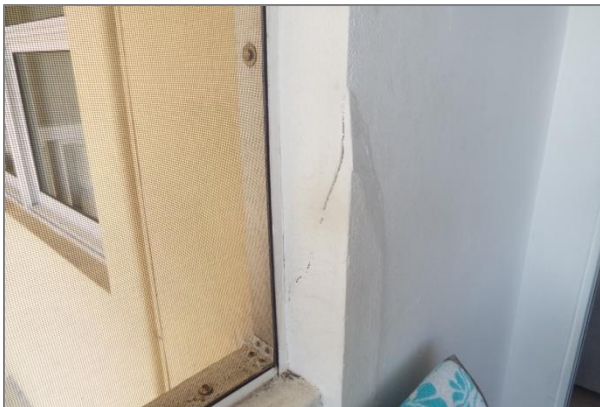
**Unit 306**

***Spalled Concrete At NE Corner Of Balcony.***

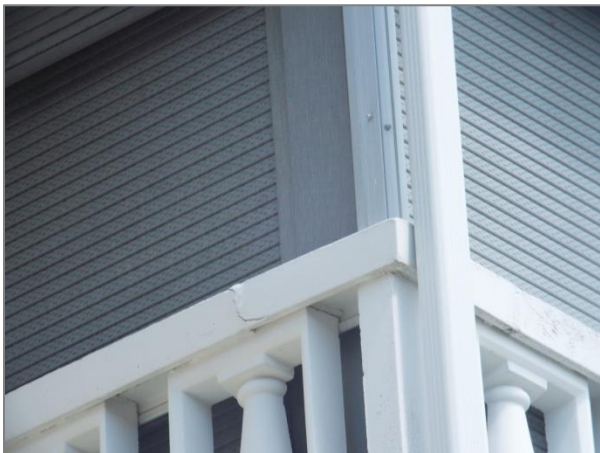
**Unit 306**

***Top Of Concrete Bannister Is Broken At NW Corner Of Balcony.***

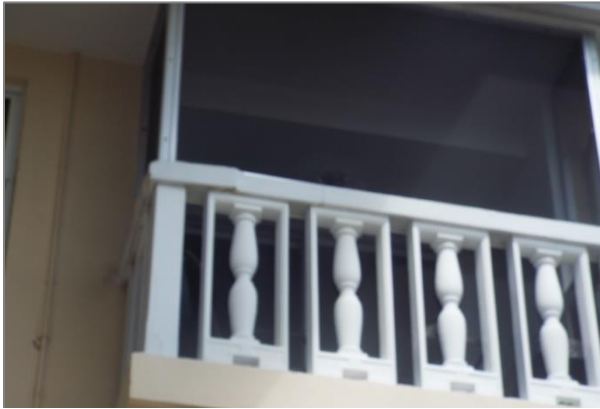
**Unit 307**

***Top Of Concrete Bannister Is Broken At NW  
Corner Of Balcony.***

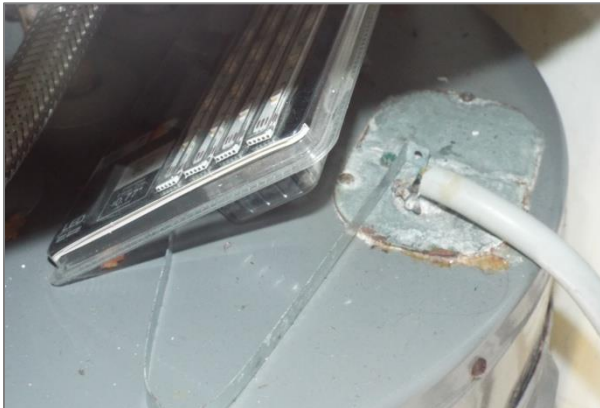
**Unit 308**

***Bad Wire Connection On Top Of Water Heater.***
